Geological mapping of slope for diversion tunnel outlet

PROJECT TITLE				
Upper Trishuli-1 HEP (216MW)				
OWNER				
OWNER'S ENGINEER				
CONTRACTOR				
DRAWING TITLE				
Geological mapping of slope for diversion tunnel outlet				
INDEX	DRAWING NUMBER	SHEET NO.	REV. NO.	
A	UT1-C-855-G-diversion-02	1 OF 1	0

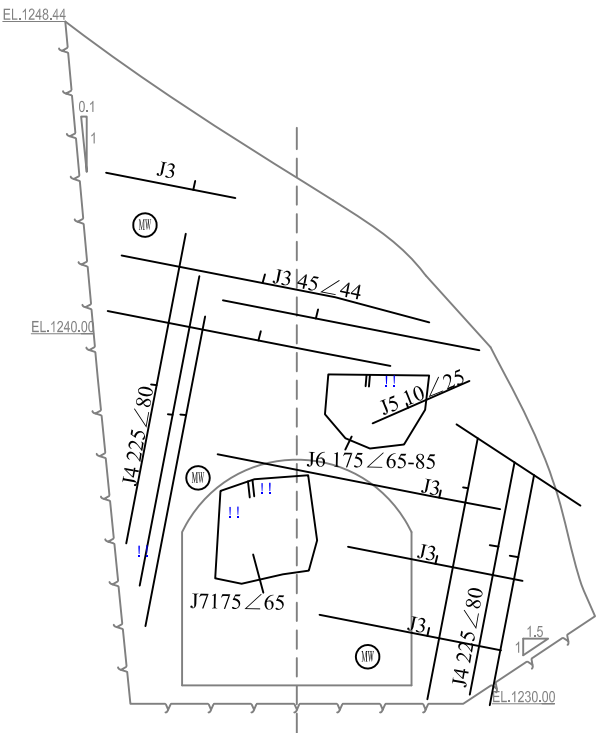
Summary of Geological Conditions

Slope Elevation	EL. 1230. 00-EL. 1248. 44
Rock types	Mi+Qu Sch
Rock hardness	Medium hard rock
Degree of weathered	Moderately weathered
Rock attitude (Dip direction/dip)	45° ∠44°
Rock mass classification	III
Groundwater situation	Dry local dripping

STAKE	TUNNEL	ROCTYPEK	UCS	GROUND WATER	RQD	Jv	Jn	Jr	Ja	Jw	SRF	Q= $\frac{RQD \times J_r \times J_w}{J_n \times J_a \times SRF}$	ROCKMASS CLASS	DATE
	DIRECTION	Mi+Qu Sch		GW1	70	13.6	6	1.5	1	1	2.5	7	III	2022.1.16
NO.	Occurrence		SEPARATION (m)	JOINTS GROUP		PERSISTENCE	ROUGHNESS/ APPEARANCE	FILLING	WEATHER OF ROCK WALL	FAULT		UCS		
	Dip direction	Dip angle		SPACING	NUMBER					INFLUENCEDZONE (m)	NATURE	Very high	>250	
												High	100-250	
												medim high	50-100	
J3	45	44	C1	SP1	20	C3	R2	F3、F4	W3			moderate	25-50	
J4	225	80	C2	SP1	8	C3	R2	F4	W3			Low	5-25	
J5	10	25	C2			C2	R2	F4	W3			Very low	1-5	
J6(Plane)	175	65-85	C0			C2	R4		W3			RQD%		
J7(Plane)	175	65	C0			C2	R4		W3			Excellent quality	90-100%	
	SEPARATION(APERATURE)		SPACING OF JOINTS		PERSISTENCE		ROUGHNESS/APPEARANCE		FILLING		Good quality		75-90%	
	C0:Very tight <0.1mm		SP1:VERY WIDE >2m		C1:Very Low <1m		R1:very rough surfaces		F1:rock sillar F8: Breccia		Fair quality		50-75%
